Mottagare: Kontrollanter, kontrollantelever, klubbars CI	Datum: 2021-02-13	Bilaga UPT Instr-064	Blad nr: 1 av 1
Fastställt av MK: 2021-02-13	Ersätter: M-varning 2021/1	Ärende: Materielmeddelande nr. 2021/1	
		Utfärdare: SFF Materielkommitté (MK)

**VECTOR 3SE RESERVE PIN COVER FIELD MODIFICATION****Overview**

Modification of the bottom tuck tab of the Vector 3 SE Reserve Pin Cover for container sizes V360-1, V360-2, V360-3, V361, V364 and V364-1 built between May 2013 and January 2021.

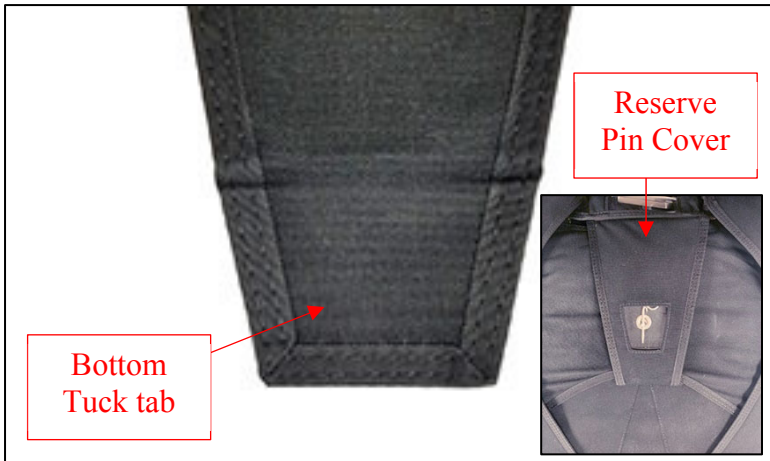
Identify the Reserve Pin Cover flap bottom "Tuck Tab".
