Mottagare: Kontrollanter, kontrollantelever, CI alla klubbar	Datum: 2019-10-09	BilagService Bulletin	Blad nr: 1 av 1
Fastställt av MK: 2019-10-09		Ärende: Materielvarning nr. 2019/1	
Ersätter:		Utfärdare: SFF Materielkommitté (MK)

Service Bulletin 2017-002

Subject: Ring position on SIFE main risers

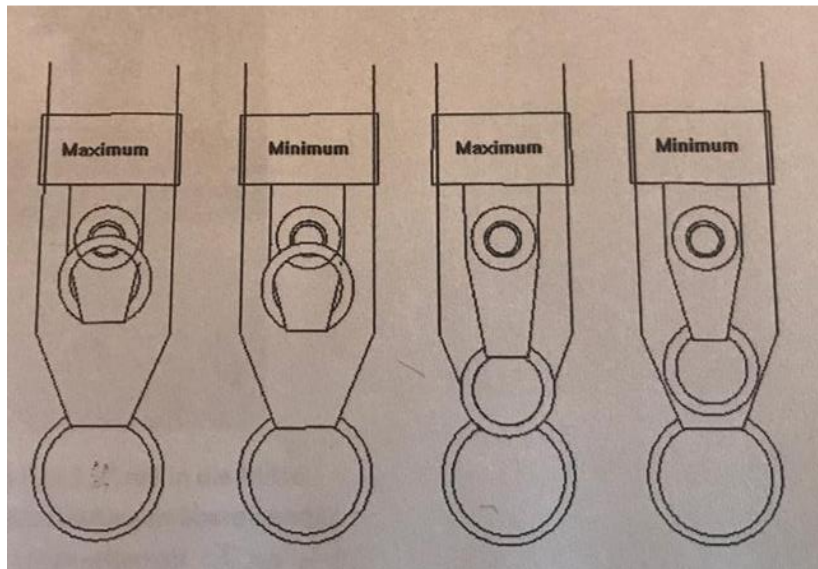
We have been informed that during the simulation of a cutaway procedure, the 3-ring-system released only after a short tug on the risers. The result of our investigations is that the position of the small ring on the affected main risers may not meet the design specifications.

1. Check the ring position on your main risers with the following figure:

2. If your main risers do not meet the design specifications, or if you are unsure please send us an e-mail to office@sife.at.

The main riser replacement will be free of charge.
